DEPARTMENT OF NATURAL RESOURCES
DIVISION OF OIL, GAS AND MINING

RE: Site Inspection, U. S. Energy Corp., Velvet Mine, M/037/040, San Juan County, Utah

Date of Inspection: May 29, 2003
Time of Inspection: 10:30 a.m. to 1:30 p.m.
Conditions: Mostly clear, 80's
Participants: Ted McDougall (BLM), Fred Craft (U. S. Energy), Jim Butt (contractor for U. S. Energy), and Paul Baker (DOGM)

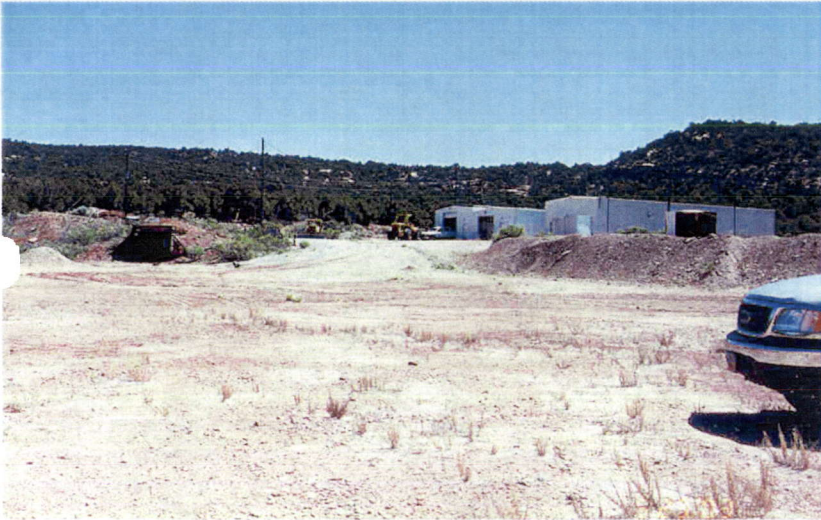
We first discussed reclamation of the portal. Photo 1 shows the portal and some of the surrounding area. The portal begins by going through unconsolidated material, then there is a section about 50 feet long where the rock is supported by a continuous wood ceiling, then there is no continuous support (I assume there are roof bolts). The operator intends to backfill the 50-foot section where there is a continuous ceiling. The entrance section will be collapsed and mounded to keep water from piping into the portal.

Photo 1. The portal is in the left center portion of this picture.

Mr. McDougall and I agreed the portal reclamation plan should be adequate. The contractor should attempt to fill the 50-foot section as completely as possible.

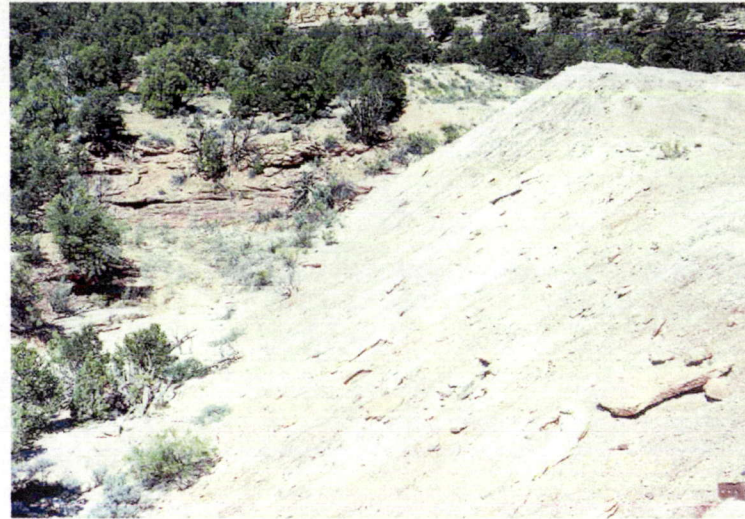
We next discussed reclamation of the pad and waste material. Currently, there is a relatively flat pad with steep slopes extending into adjacent drainages (Photos 2 and 3). There are two levels of waste, the higher one being toward the east. We do not know what is under the waste and whether there might be layers of rock that would prevent the operator from grading the area as planned (see discussion below).

Photo 3. The outslope of the waste pile.

Mr. Butt intends to reduce the outslopes to no steeper than 3h:1v without expanding the waste slope into the drainages. If bedrock is encountered during grading, the plan will need to be modified. A berm will be placed around the edge of the pad, and the slopes will be terraced and left as rough as reasonably possible. The pad will be sloped away from the drainage back toward the hill on the north. A channel will be placed on the northwest side of the pad and possibly one on the northeast side to take water off the pad into small drainages. With the top of the pad sloped back and channels placed near where the pad intersects the hill, the constructed drainages should be short, not too steep, and not as prone to erosion compared to having the water come off the face of the waste slopes.

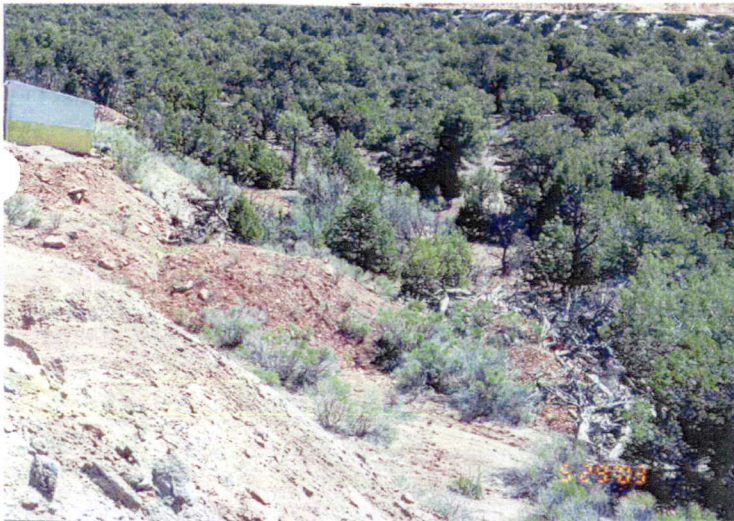
There are some small piles of soil in various places around the site, but it does not appear there is enough salvaged soil to cover the entire site as much as six inches deep. No volume calculations are available. One of the soil stockpiles is shown in Photo 2. To the west of the mine site, there was an area with some alluvial soil material that could be used as borrow (center of photo 4). The soil in the potential borrow area appeared to have few rocks, but there were some rocks in the other stockpiles.

Photo 2. The outslope of the waste pile and, just to the left of center, a soil stockpile.

We discussed how to best use the limited soils. As a general rule, soils with fewer rocks should be placed on the top of the pad, and soils with more rocks would be placed on the slopes. Since there will probably be a soil deficit, the top of the pad would receive soil preferentially over the slopes. Once the top of the pad has about six inches of soil, remaining soil will be placed on the slopes. There are two reasons for preferring the pad. Foremost, because most of the soil came from flatter areas, most of it does not have a lot of coarse fragments. If placed on the slopes, it would probably be more prone to

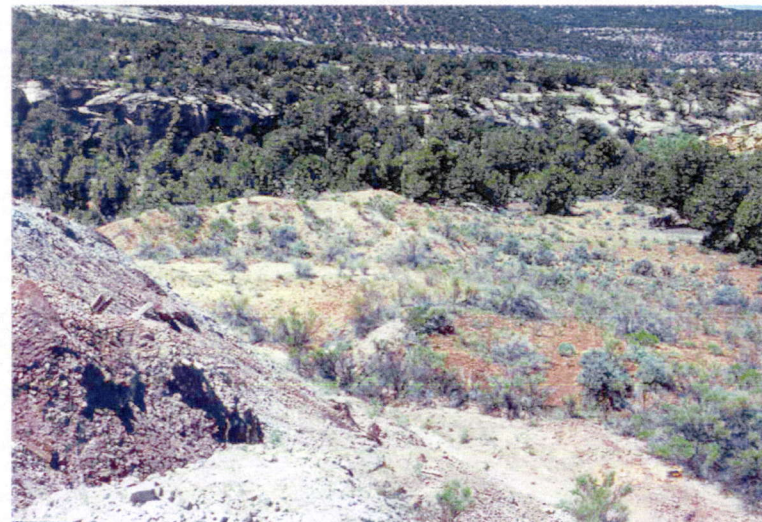
Photo 4. To the right of the waste pile outslope is an area with soil that could be used as borrow.

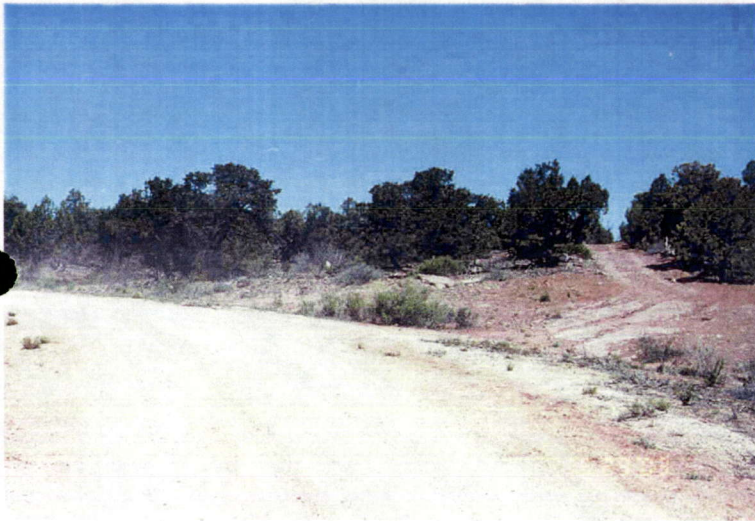
The access road leading to the main mine site is classified as a Class B road by San Juan County, apparently part of road #112. The road dead ends at the mine, but about 200 yards before reaching the mine, there is another road, classified by the county as an OHV road, leading north (Photo 5). Photo 6 shows the portion of the main access road between the OHV road and the mine. Just to the east of the OHV road, between the road and the mine, there is a culvert under the access road where it crosses a drainage.

Photo 5. The mine access road looking away from the mine. On the right side is the OHV road leading north.

The main access road to the mine will be reclaimed from the mine back to the OHV road. We could not see a purpose in keeping the road all the way to the mine since it dead ends there, and reclaiming the road would discourage people from getting to the mine and possibly damaging reestablished vegetation. Reclamation will include removing the culvert, ripping and seeding the road, and installing water bars as needed.

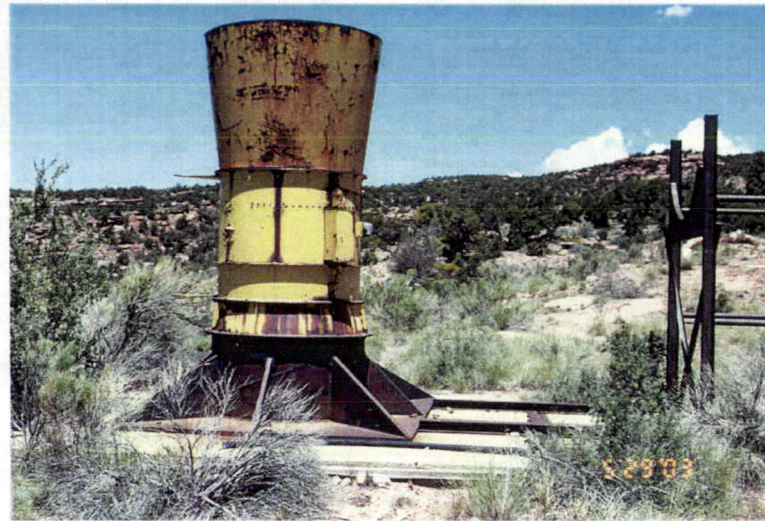
There are three ventilation shafts, and one of these has a headframe and hoist house (Photos 7 and 8). At the ventilation shafts, the top of the casing was placed in such a way that the casing extends about one or two feet above the ground surface. There is a large metal plate on the surface attached to and surrounding the casing (Photo 7). The purpose of the metal plate was to have a more secure base to which the casing could be attached.

Photo 7. One of the vent shafts. This photo clearly shows the plate attached to the casing and to the fan.

The mine plan says the vent holes will be sealed by welding a steel plate to the casing and covering this with fill/soil. During this inspection, the operator proposed to cap the vent holes with reinforced concrete. The plates around the casings would be left in place to provide stability, and the concrete would come over the sides of the casings down to the plates. The concrete would then be covered with soil and the area revegetated. Mr. McDougall and I agreed this would be a much better way to seal these shafts than the approved method, and I felt it should be adequate.

At all of the vent shafts, the operator should try to redisturb as little area as possible. Native vegetation has become well established at these sites.

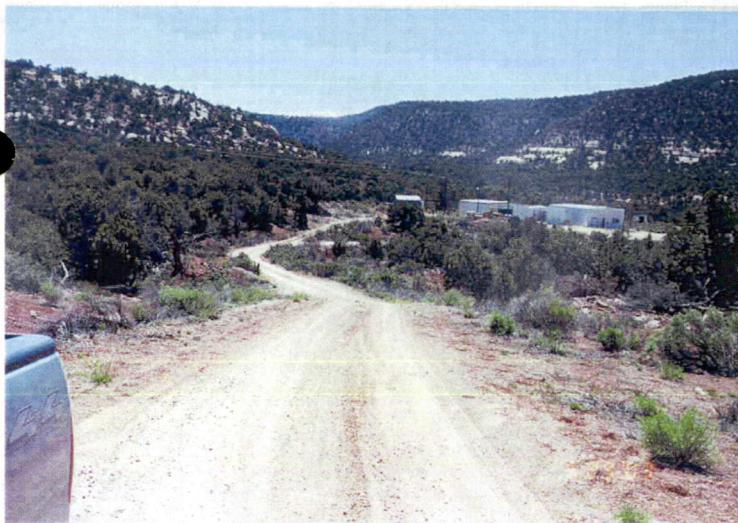
Photo 6. The mine access road looking from the place shown in Photo 5 back to the mine.

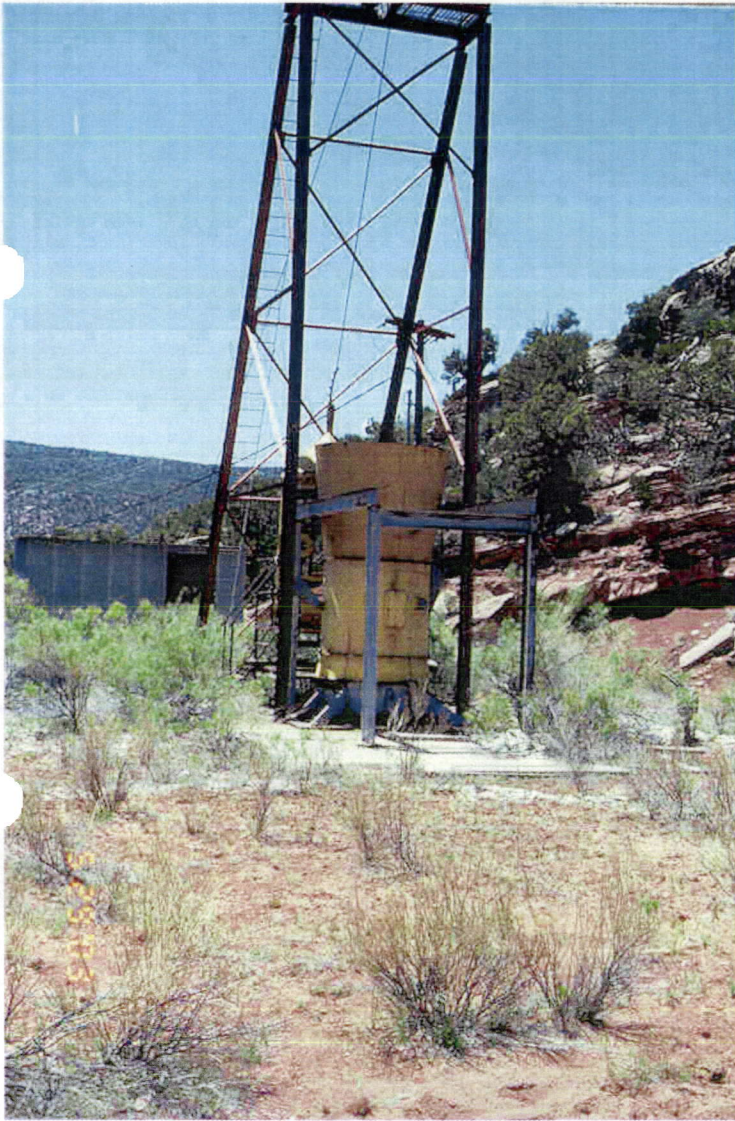
Photo 8. A vent shaft with a headframe and hoist house.
